NSWCCD-65-TR-2004/37 January 2005

SIDER Testing of Impact Damaged Sandwich Panels

Subj: SIDER INSPECTIONS OF FOUR COMPOSITE SANDWICH PANELS

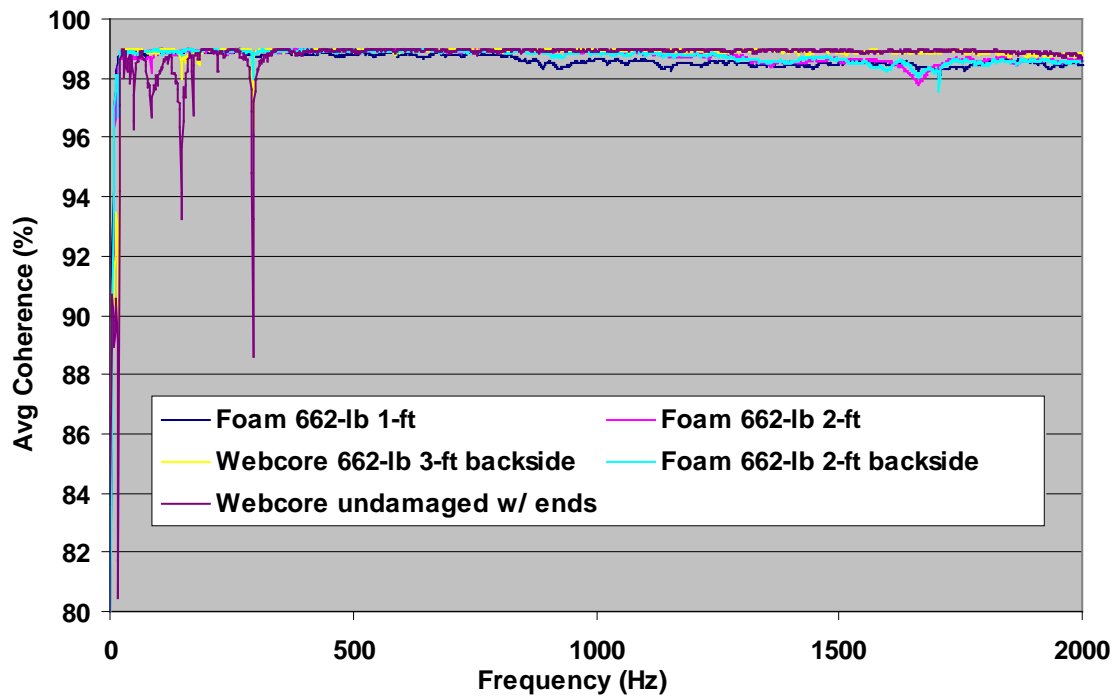
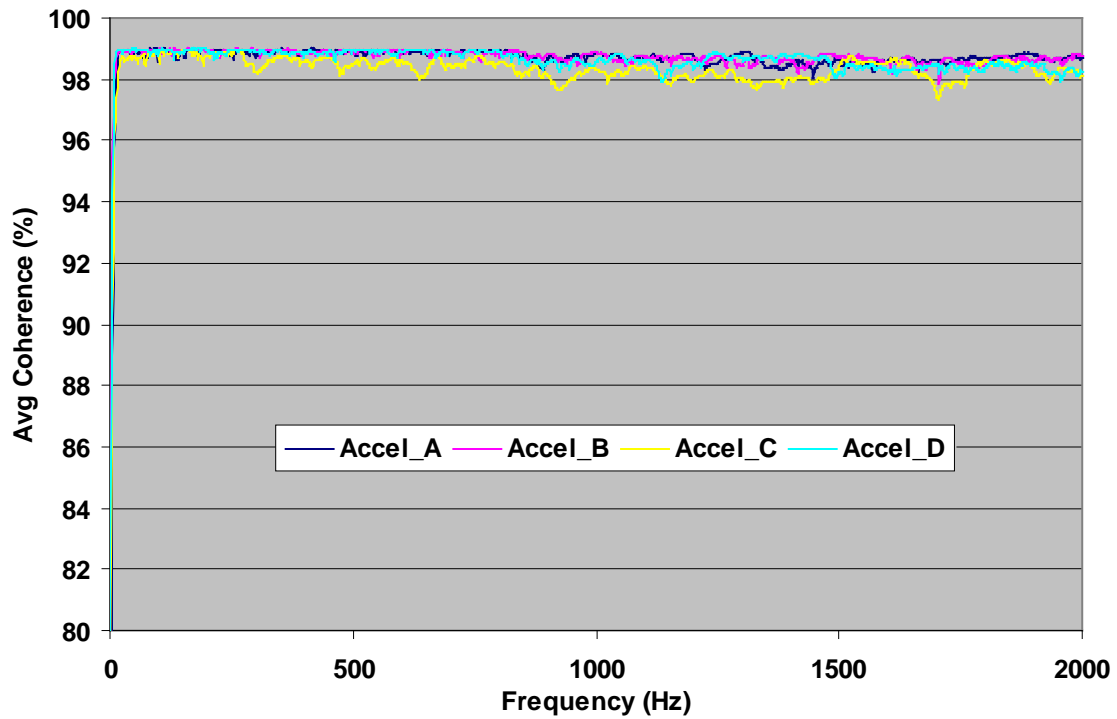
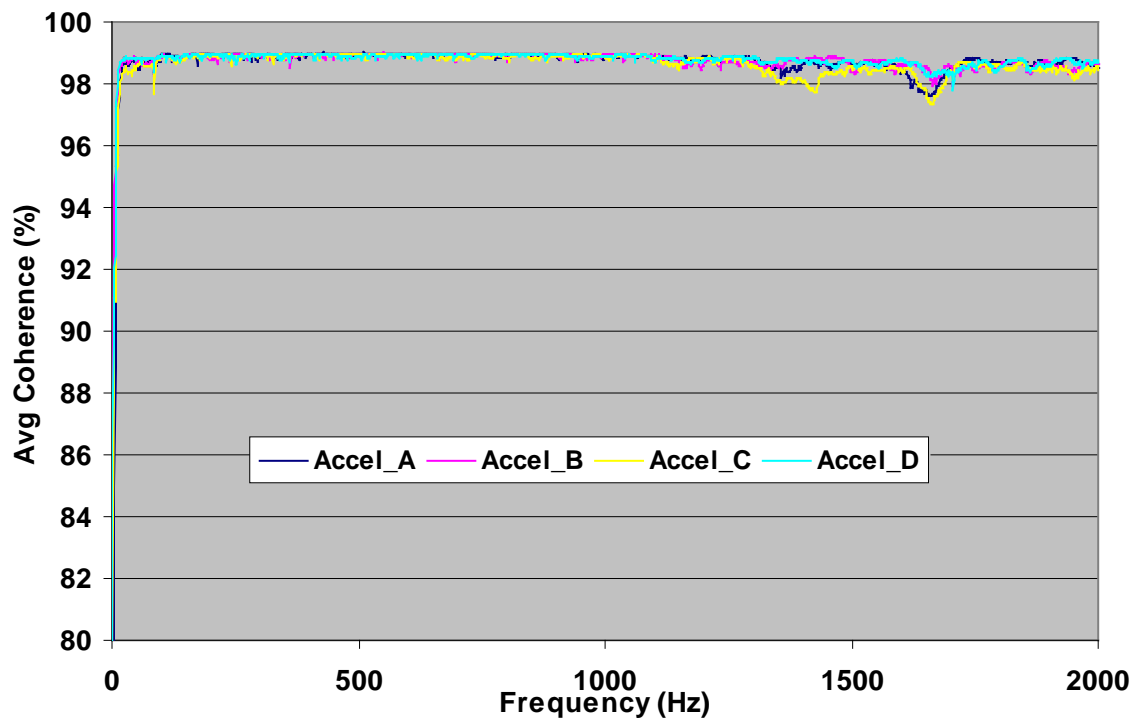
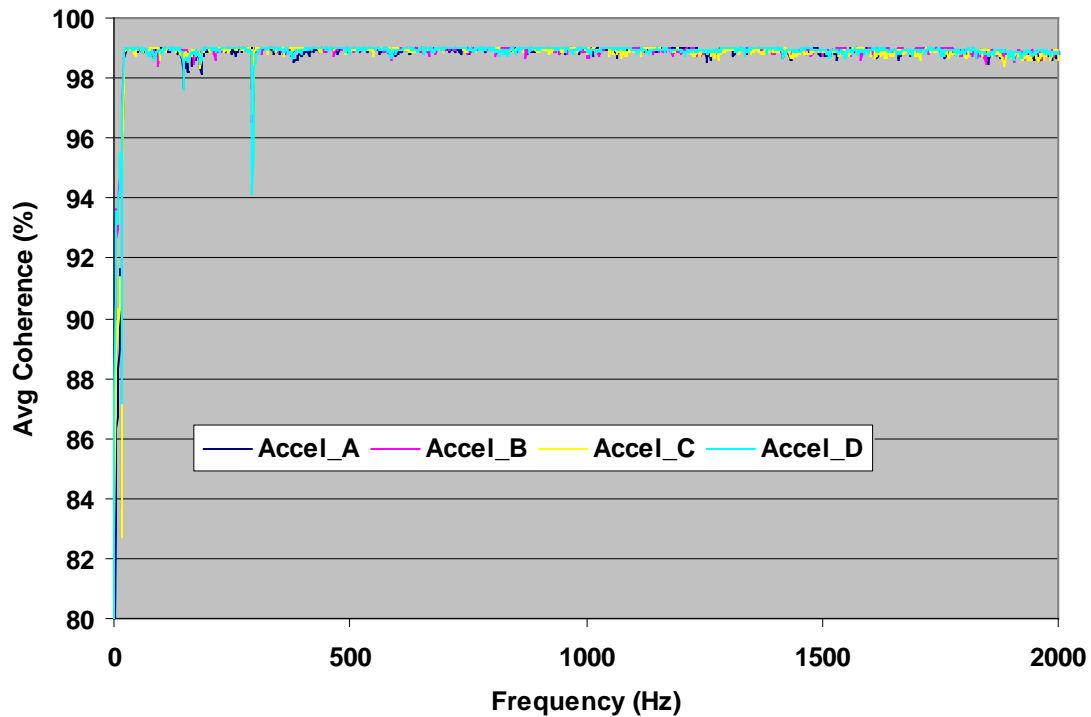
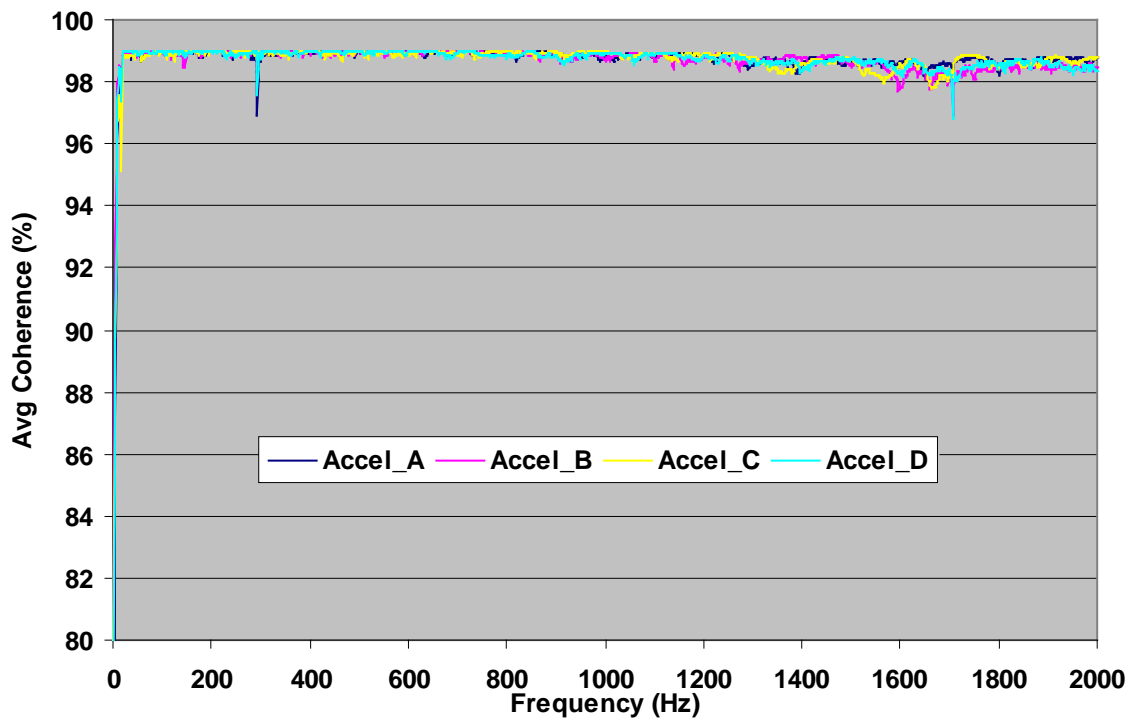
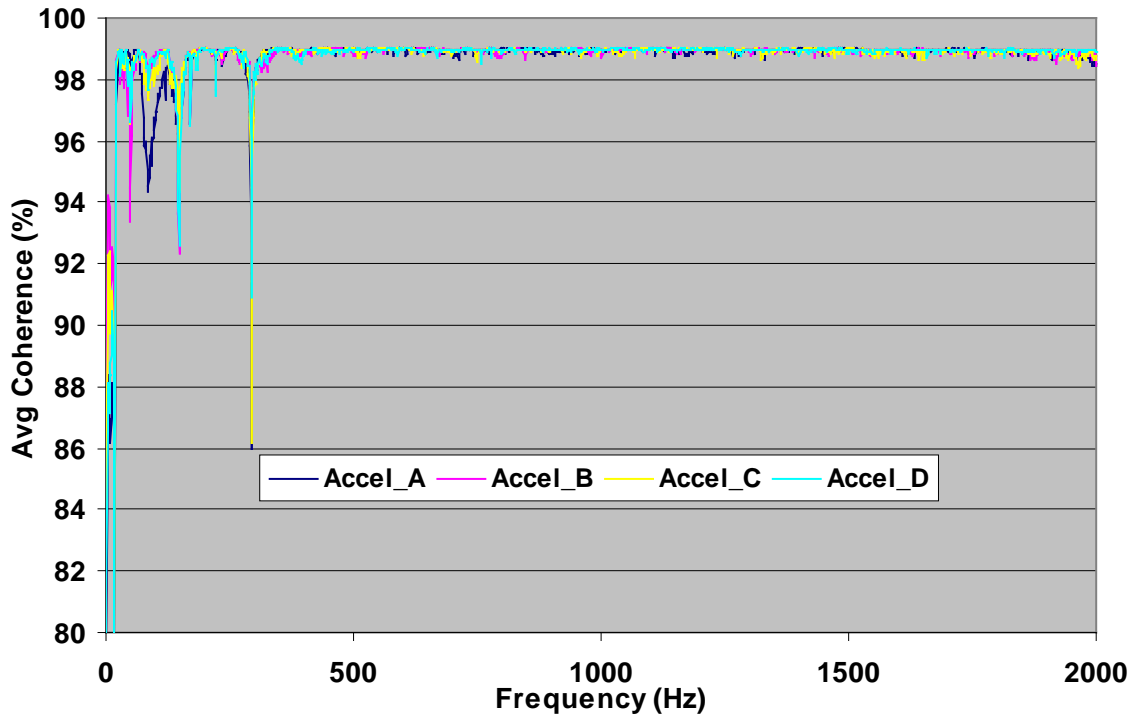
Figure 4. Average Coherence Comparison between Test Parts

For all panels and all accelerometers the data have a very good quality in the range of about 200 Hz to 1200 Hz, although all data are acceptable for SIDER analysis up to the maximum recorded frequency of 2 kHz.

Data below 200 Hz are more variable, though still of good quality. This slight degradation is typical for resonant structures and is not of concern for the SIDER analysis that typically uses higher frequency data.

Based on these results, it was decided to conduct all the SIDER analyses using data from the frequency range 200 Hz to 1200 Hz.

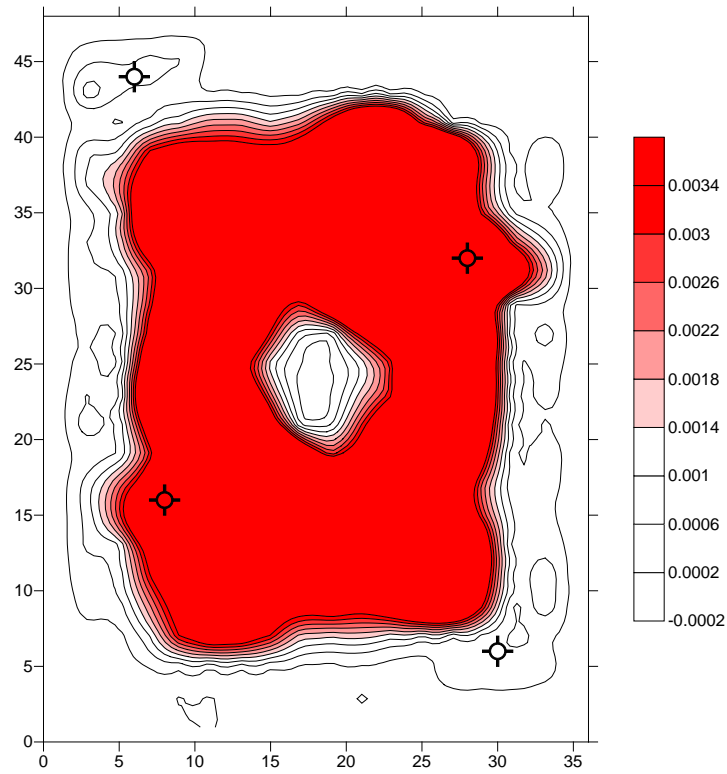
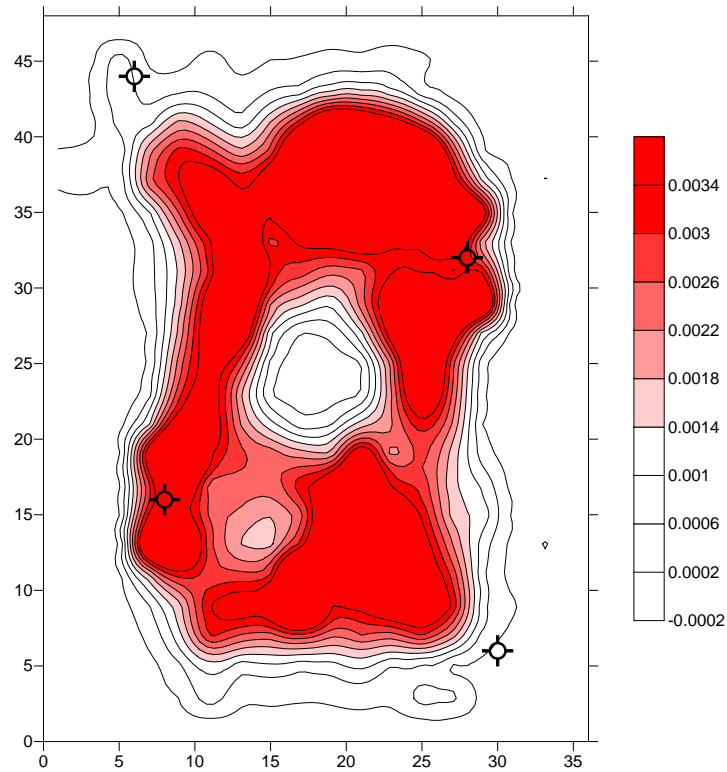
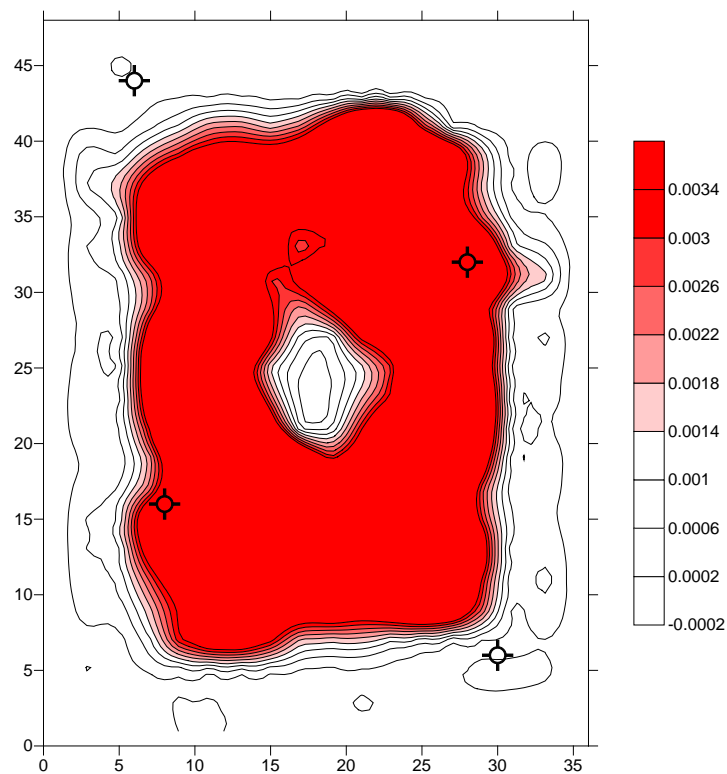
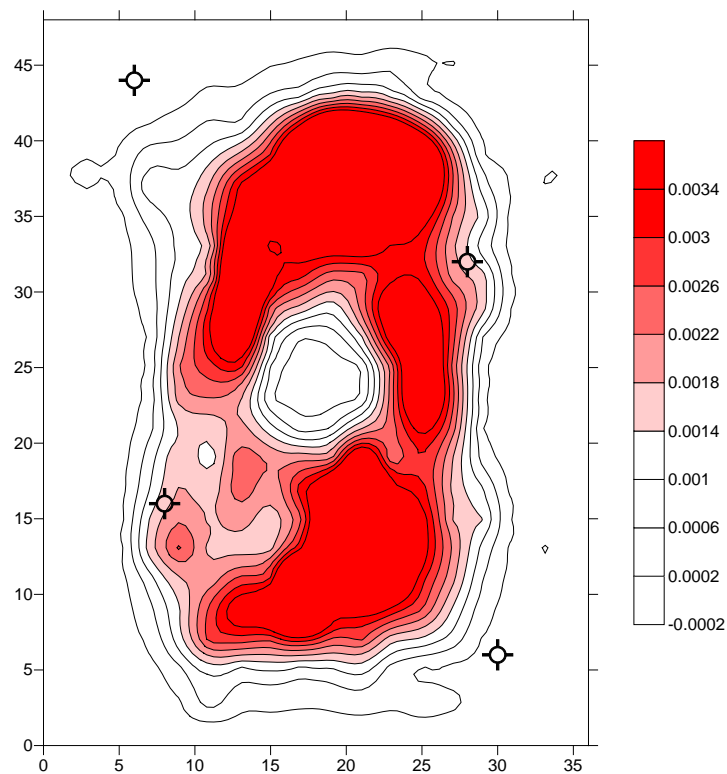
Figure 10. Foam 662-lb 1-ft (Li_1) X-Direction Analysis -Unweighted

Figure 11. Foam 662-lb 1-ft (Li_1) Y-Direction Analysis -Unweighted

Figure 12. Foam 662-lb 1-ft (Li_1) X-Direction Analysis -Pie-Plate Weighting

Figure 13. Foam 662-lb 1-ft (Li_1) Y-Direction Analysis -Pie-Plate Weighting

The SIDER test results of the foam core panels is more complex. One consistent feature for each of these panels is that the location where the impact occurred did not indicate a stiffness variation. This is typical of foam core materials. Typically, the impact area does not see a large variation in spatial stiffness. Damage emanates a certain distance from the actual impact site. The other features indicated by SIDER are more confusing. The lower impact energy panel, L_1, shows a larger area of structural variation than panel L_2, which was impacted with twice the impact energy. It is not known if there was any difference in the way that the panels were impacted. There is the possibility that when panel L_1 was impacted, that the impactor was allowed to rebound and impact a second time since the height of the drop was only 1 foot. In any event, SIDER would indicate that there is a larger area of concern than for panel L_1 than for L_2.

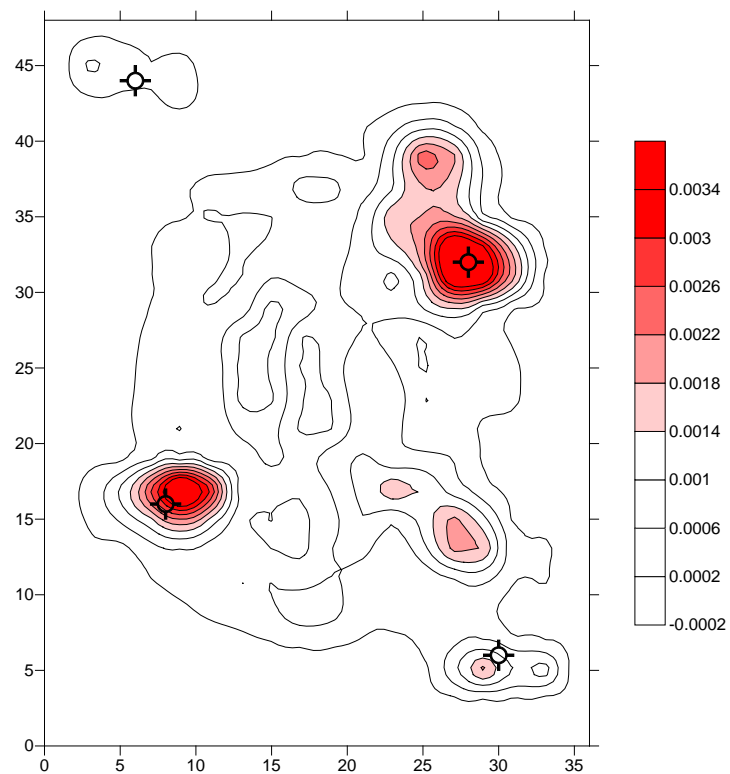
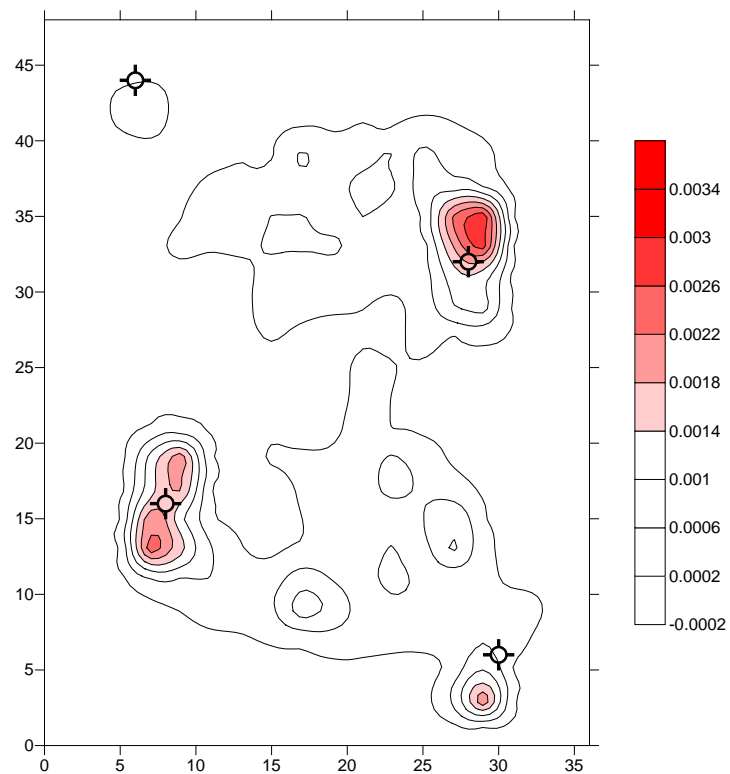
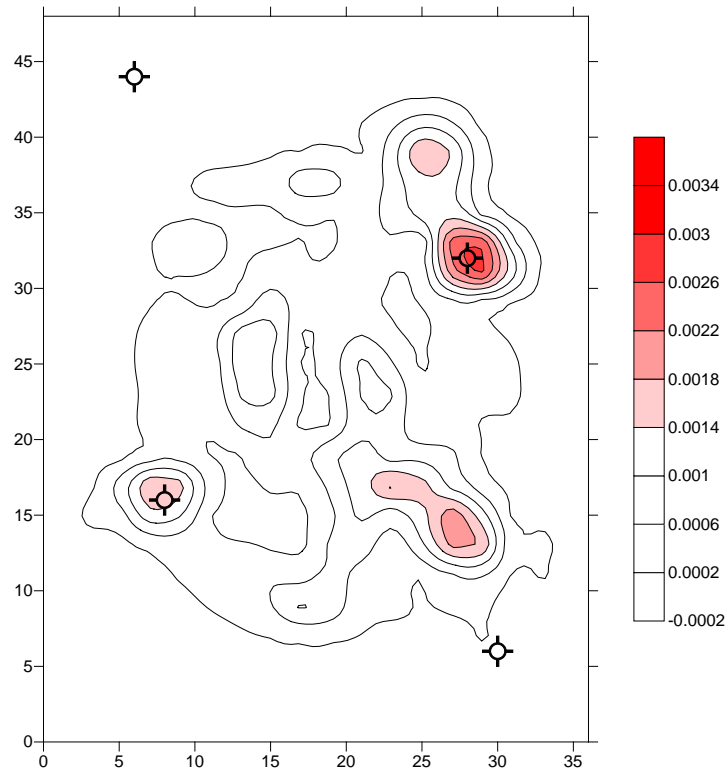
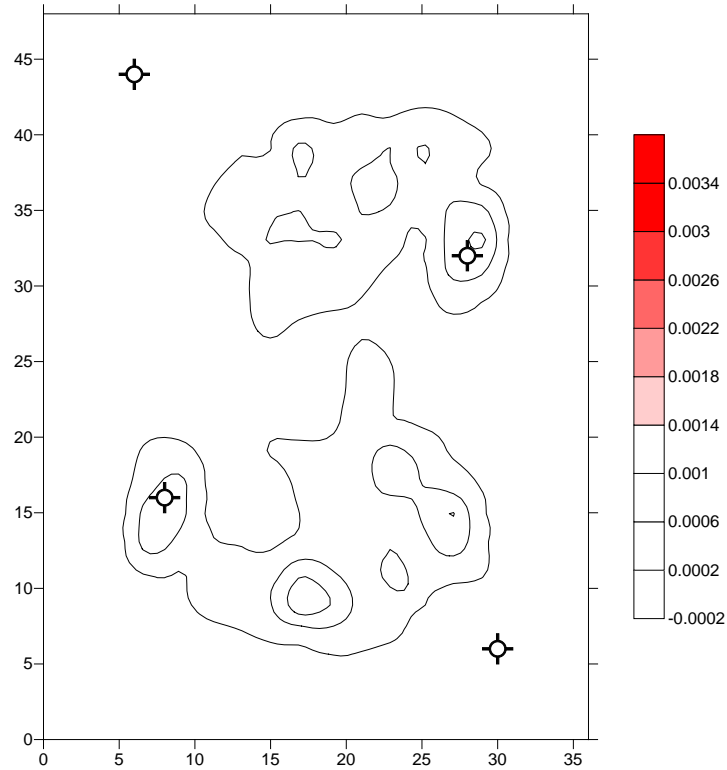
Figure 14. Foam 662-lb 2-ft (Li_2) X-Direction Analysis -Unweighted

Figure 15. Foam 662-lb 2-ft (Li_2) Y-Direction Analysis -Unweighted

Figure 16. Foam 662-lb 2-ft (Li_2) X-Direction Analysis -Pie-Plate Weighting

Figure 17. Foam 662-lb 2-ft (Li_2) Y-Direction Analysis -Pie-Plate Weighting

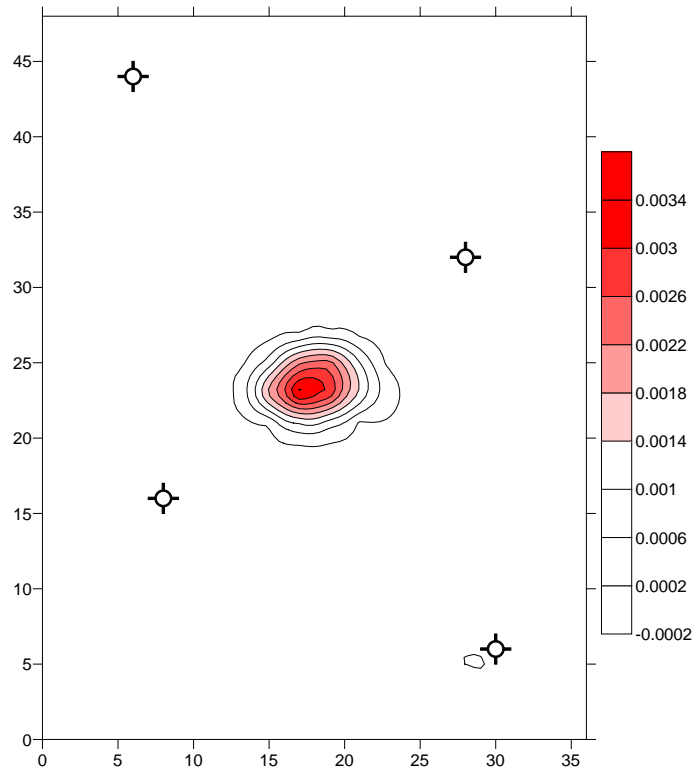
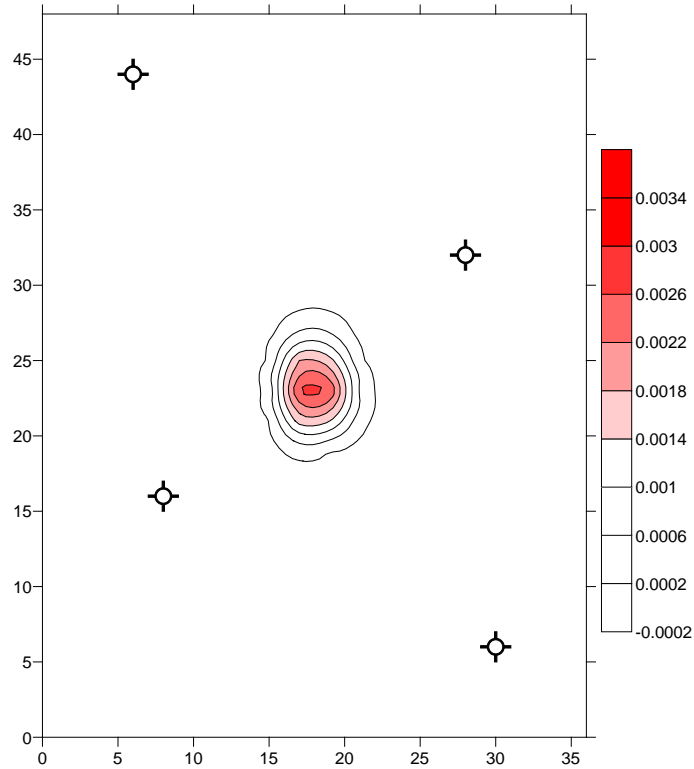
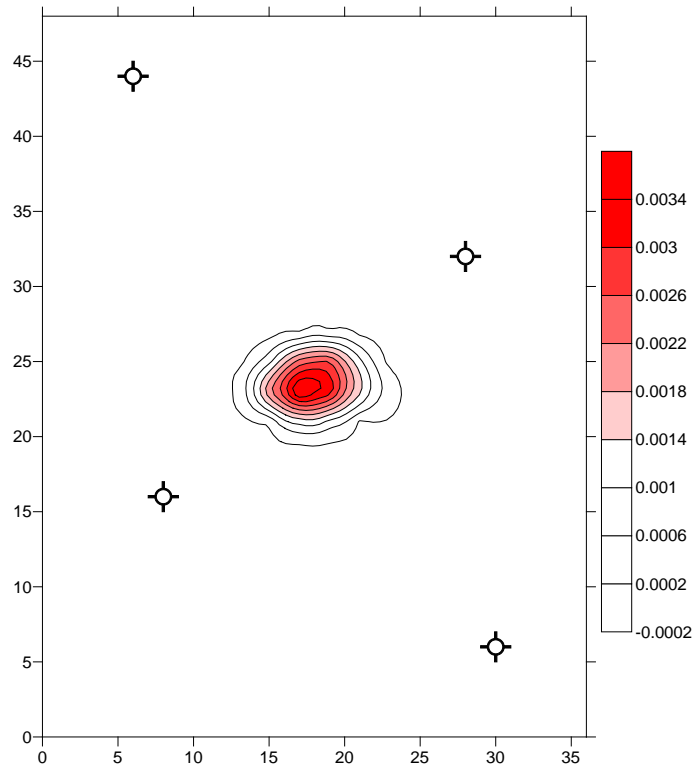
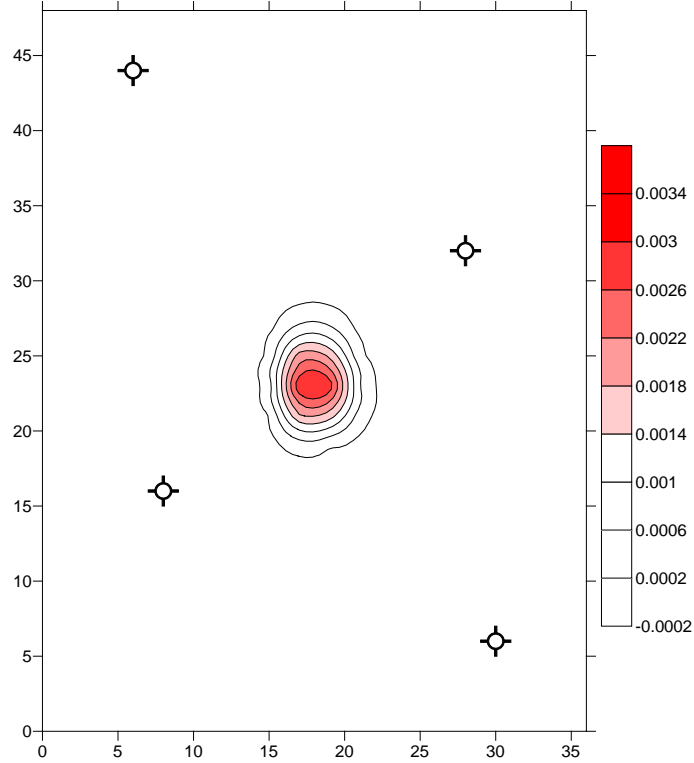
**Figure 18. Webcore 662-lb 3-ft (Li_3) X-Direction Analysis
– Unweighted – Backside Test**

**Figure 19. Webcore 662-lb 3-ft (Li_3) Y-Direction Analysis
- Unweighted – Backside Test**

**Figure 20. Webcore 662-lb 3-ft (Li_3) X-Direction Analysis
- Pie-Plate Weighting – Backside Test**

**Figure 21. Webcore 662-lb 3-ft (Li_3) y-Direction Analysis
- Pie-Plate Weighting – Backside Test**

The SIDER test results from two Webcore panels are discussed first. The panel that had not been tested, L_5, showed a uniform SIDER value over most of the panel with only minor indications near the end fixtures. This shows that the panel was manufactured with a consistent quality. For impacted Webcore panel, L_3, the only indication of structural variation is in the center of the panel, where it was impacted with the drop weight. This is consistent with prior SIDER testing on Webcore impacted panels. The damage has been shown to be highly localized and of a minimal size.

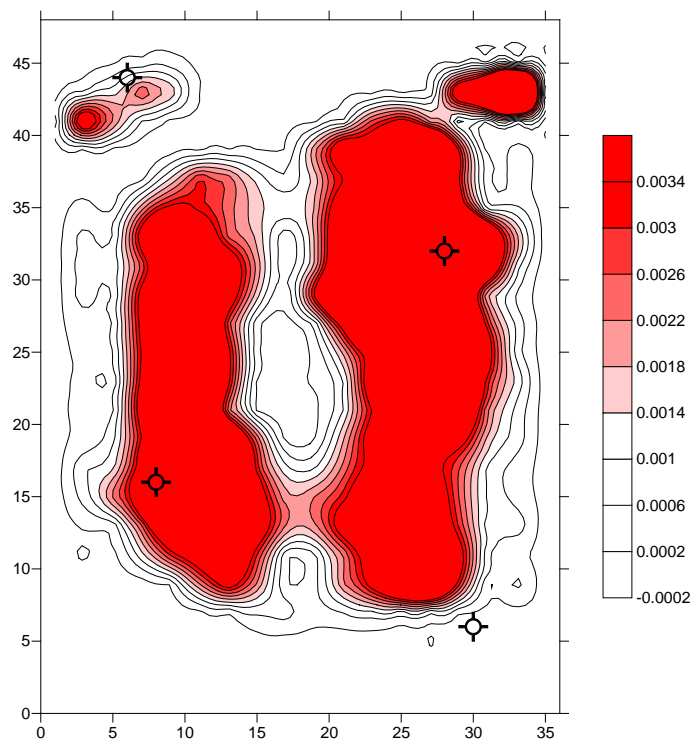
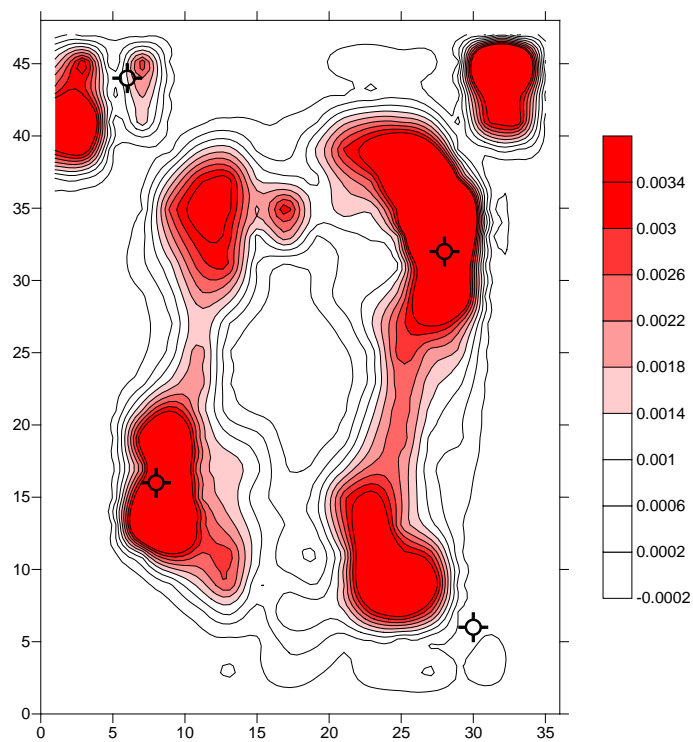
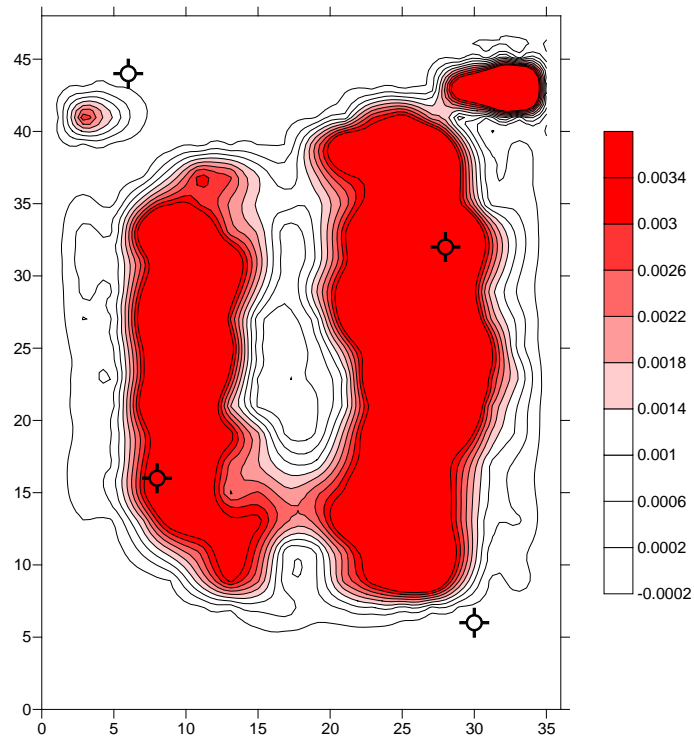
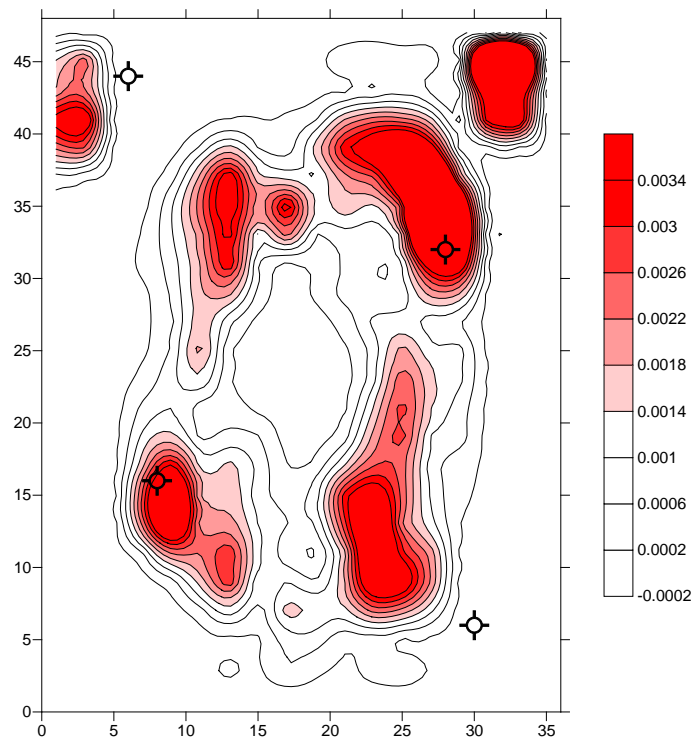
**Figure 22. Foam 662-lb 2-ft (Li_4) x-Direction Analysis
– Unweighted – Backside Test**

**Figure 23. Foam 662-lb 2-ft (Li_4) Y-Direction Analysis
– Unweighted – Backside Test**

**Figure 24. Foam 662-lb 2-ft (Li_4) x-Direction Analysis -Pie-Plate Weighting
– Backside Test**

**Figure 25. Foam 662-lb 2-ft (Li_4) y-Direction Analysis -Pie-Plate Weighting
– Backside Test**

The other comparison that needs addressing is the SIDER result from testing panel L_2 on the impact side and the side opposite the impact, indicated as Backside test in the figures. There is an obvious difference between the SIDER results from these two tests. Figure 22 through Figure 25 show a much larger area of structural variability than on the backside of the panel, which is shown in Figure 14 through Figure 17. This is not atypical since flexural deformation of composite sandwich structures often have more damage on the tensile surface than the compression surface. What is consistent, though, is that the areas of structural variability occur more along the y-axis of the panel than in the x-direction.

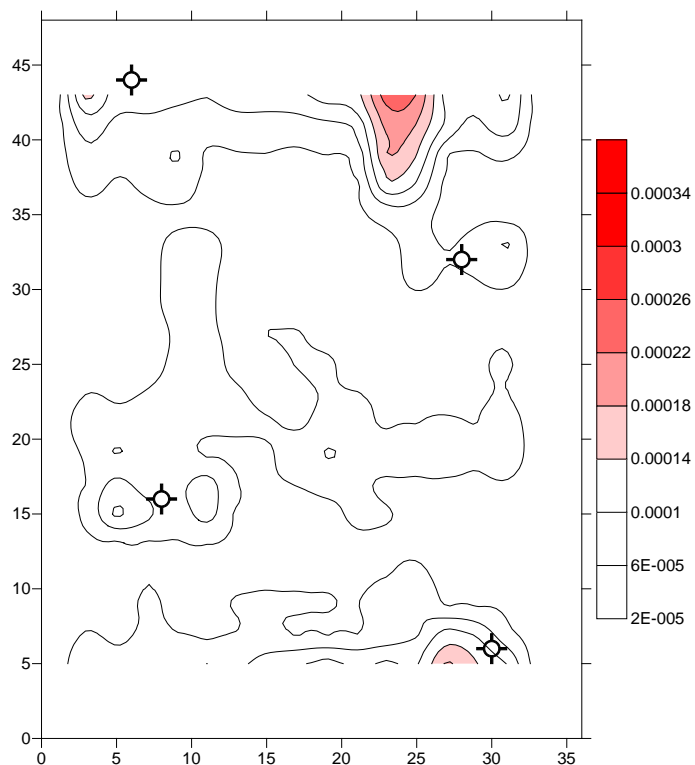
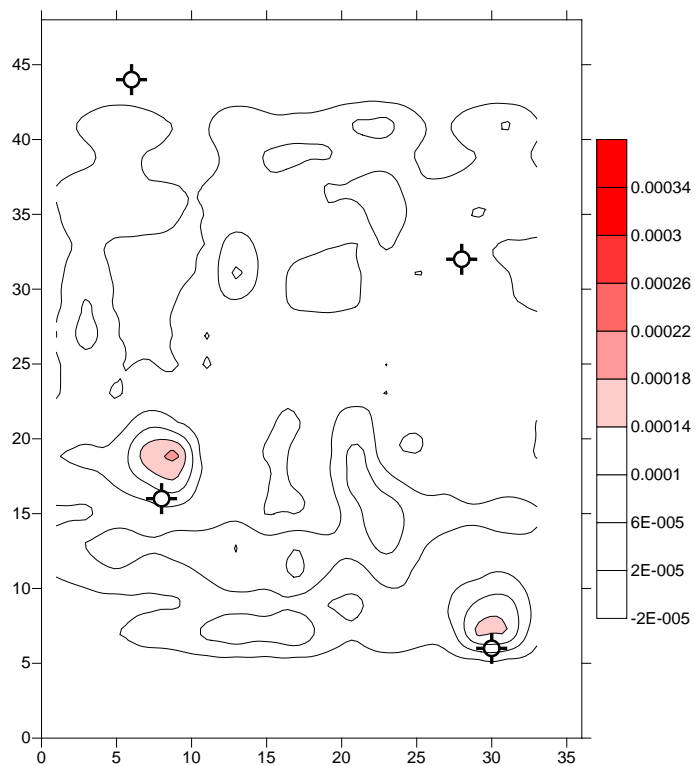
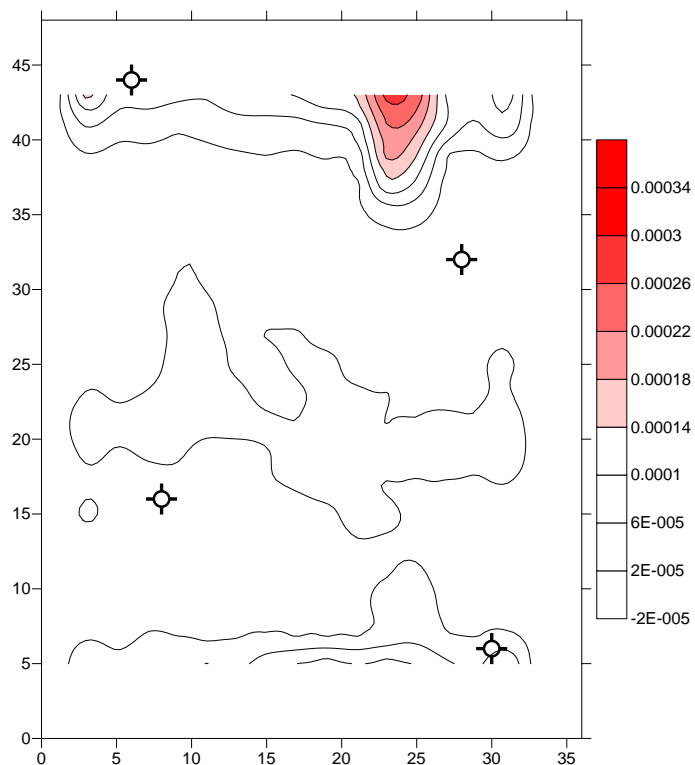
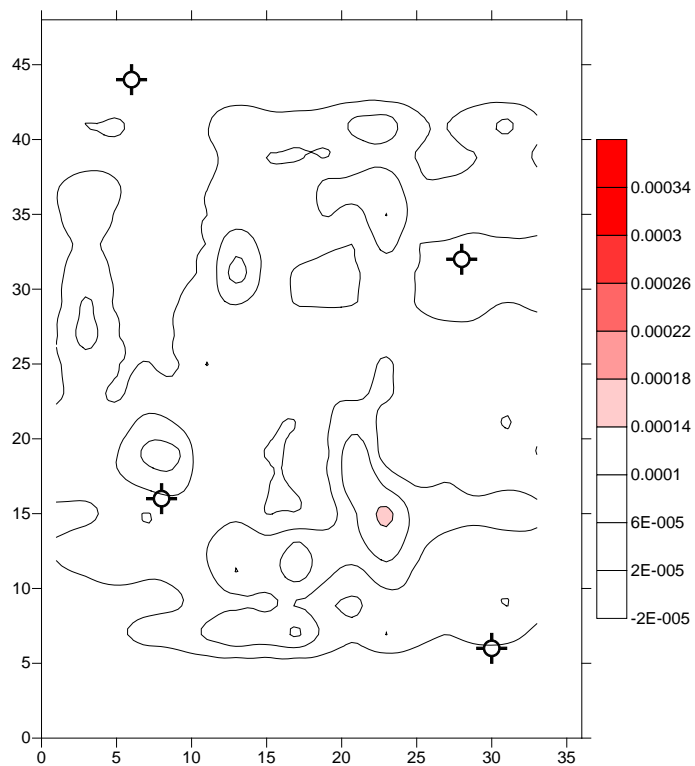
**Figure 26. Webcore Undamaged (Li_5) x-Direction Analysis
– Unweighted 10 × Magnification**

**Figure 27. Webcore Undamaged (Li_5) y-Direction Analysis
– Unweighted 10 × Magnification**

**Figure 28. Webcore Undamaged (Li_5) x-Direction Analysis
-Pie-Plate Weighting 10 × Magnification**

**Figure 29. Webcore Undamaged (Li_5) y-Direction Analysis
-Pie-Plate Weighting 10 × Magnification**
